Quality Assurance and Source Inspection

Contract #: 04-0120F4Cty: SF/ALA Rte: 80 PM: 13.2/13.9File #: 1.28**WELDING INSPECTION REPORT****Resident Engineer:** Siegenthaler, Peter**Address:** 333 Burma Road**City:** Oakland, CA 94607**Report No:** WIR-017480**Date Inspected:** 18-Oct-2010**Project Name:** SAS Superstructure**OSM Arrival Time:** 700**Prime Contractor:** American Bridge/Fluor Enterprises, a JV**OSM Departure Time:** 1530**Contractor:** American Bridge/Fluor Enterprises, a JV**Location:** Jobsite**CWI Name:** See below**CWI Present:** Yes No**Inspected CWI report:** Yes No N/A**Rod Oven in Use:** Yes No N/A**Electrode to specification:** Yes No N/A**Weld Procedures Followed:** Yes No N/A**Qualified Welders:** Yes No N/A**Verified Joint Fit-up:** Yes No N/A**Approved Drawings:** Yes No N/A**Approved WPS:** Yes No N/A**Delayed / Cancelled:** Yes No N/A**Bridge No:** 34-0006**Component:** SAS OBG**Summary of Items Observed:**

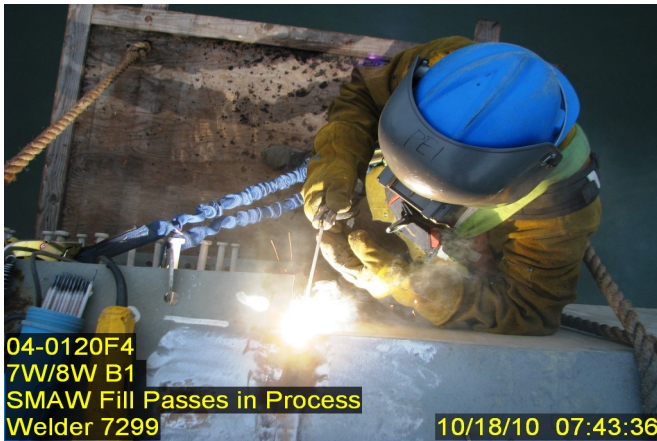
- 2). OBG Field Splice 7W/8W Weld ID: B1, Face A - (SMAW)

The QAI periodically observed the in process welding of fill and cover passes at OBG Field Splice 7W/8W weld ID: B1, from the A face per the Shielded Metal Arc Welding (SMAW) process in the 3G (vertical) position by AB/F approved welder Jin Pei Wang (ID 7299). QC Inspector Tony Sherwood was present to monitor the progress and verify that the welding parameters were within the limits established by the approved welding Procedure

Specification (WPS) identified as ABF-WPS-D1.5-1040B. The work at this location was in process for the duration of the QA Inspector's shift and appeared to be in general compliance with the contract documents. See photo below.

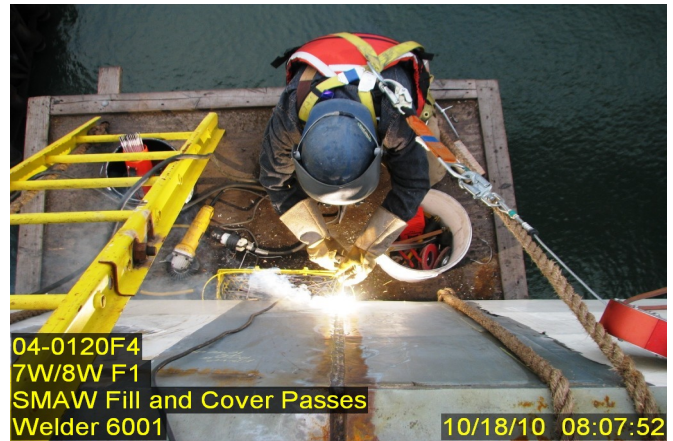
3). OBG Field Splice 7W/8W Weld ID: F1, Face A – (SMAW)

The QAI periodically observed the in process welding of fill and cover passes at OBG Field Splice 7W/8W weld ID: F1, from the A face per the SMAW process in the 3G (vertical) position by AB/F approved welder James Zhen (ID 6001). QC Inspector Tony Sherwood was present to monitor the progress and verify that the welding parameters were within the limits established by the approved welding Procedure Specification (WPS) identified as ABF-WPS-D1.5-1040B. The welding at this location was in process for the duration of the QA Inspector's shift and appeared to be in general compliance with the contract documents. See photo below.
